Seized Airends and Casting Damage Repairs

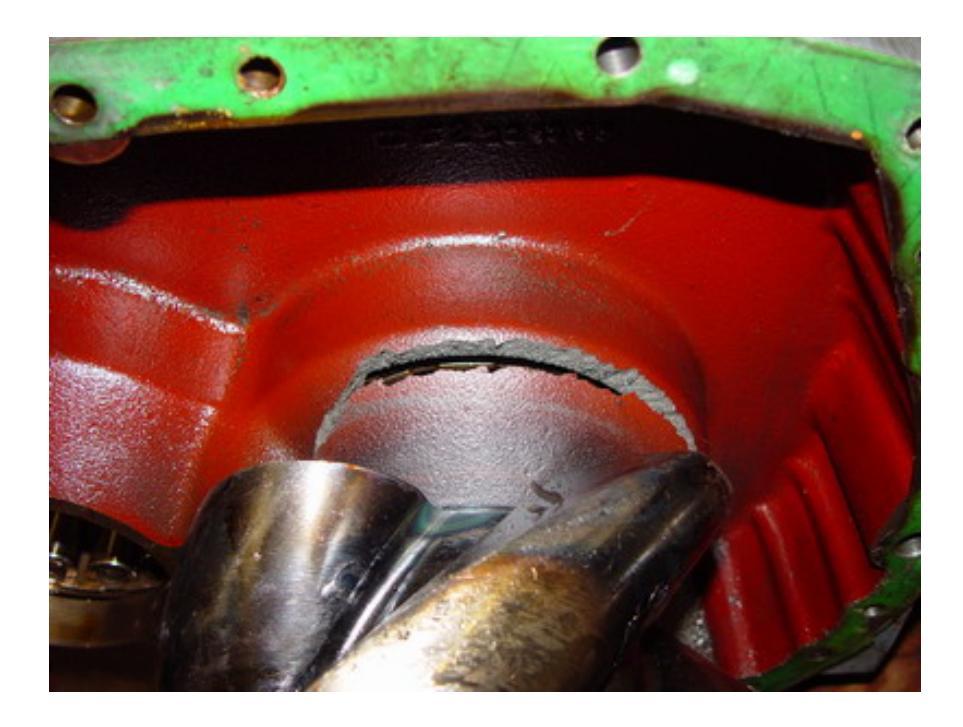
Over the years we have received for overhaul several dozen airends deemed unrepairable by other airend repair shops. When we slid the cylinder off this one it was clear that, once again, the worst damage was done at the rebuilders shop, not in the compressor failure.

In an attempt to push out the male rotor which had seized to the inlet housing of this 200 horsepower airend, the other repair house **used too much press and too little preparation** resulting in a blown apart inlet bearing housing. With no reference to how the damage occurred, they informed the servicing distributor that their customer's airend could not be repaired. The customer would need to purchase a new factory airend at full price, because their airend core was not usable, or make the choice to buy a new compressor package. **This airend could be repaired, but at a higher cost than if it had been disassembled correctly.**

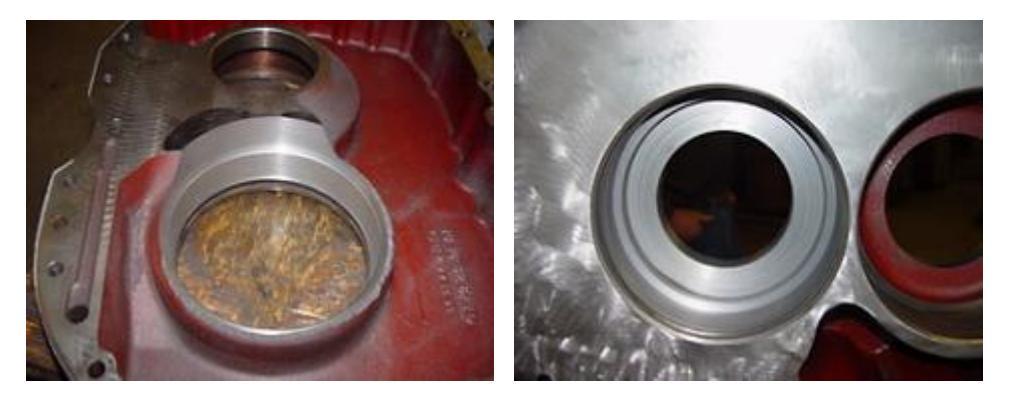
Following are some of the steps in our repair of this expensive (and not sold separately) bearing housing. This casting repair required reconstruction of the entire bearing bore and seat. All machining is done in house, and our casting repairs are guaranteed for one full year.

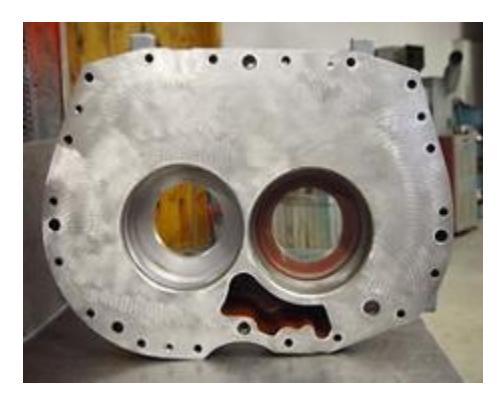
At Air Compressor Technology, we have developed non destructive techniques to disassemble and repair seized airends.

By cutting the rotors from the casting in our own machine shop we minimize unwanted fractures and distortion of expensive airend components. We have learned how to restore cylinder bores without twisting up the castings with excessive heat.

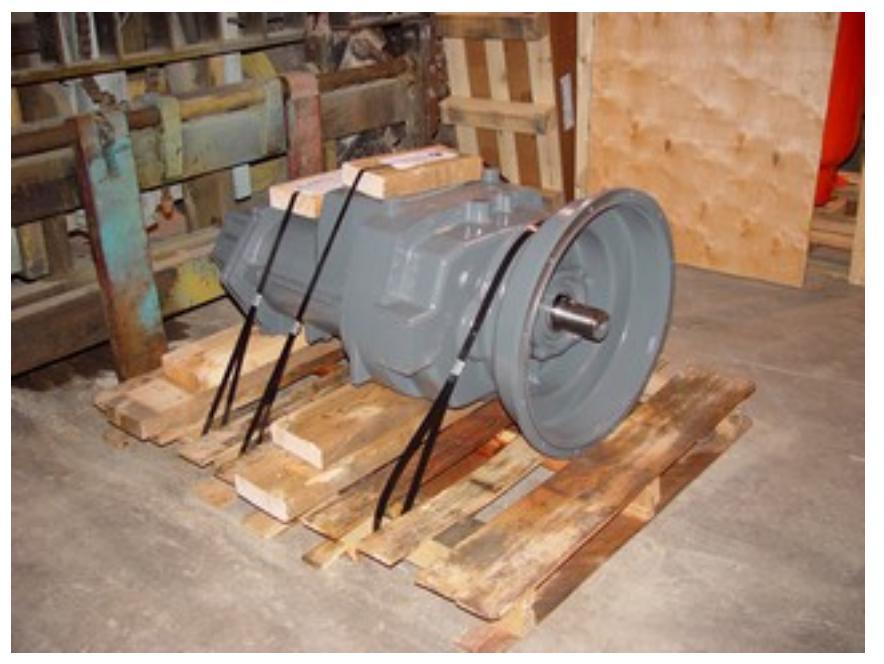
This airend shipped in February of 2008 and has been running in the field for 6 years with no reported problems.
